PRELIMINARY ASSESSMENT

**PITTSBURG ZINC SITE
PITTSBURG, KANSAS**

September, 1993

**PRELIMINARY ASSESSMENT
PITTSBURG ZINC SITE
PITTSBURG, KANSAS
SEPTEMBER, 1993**

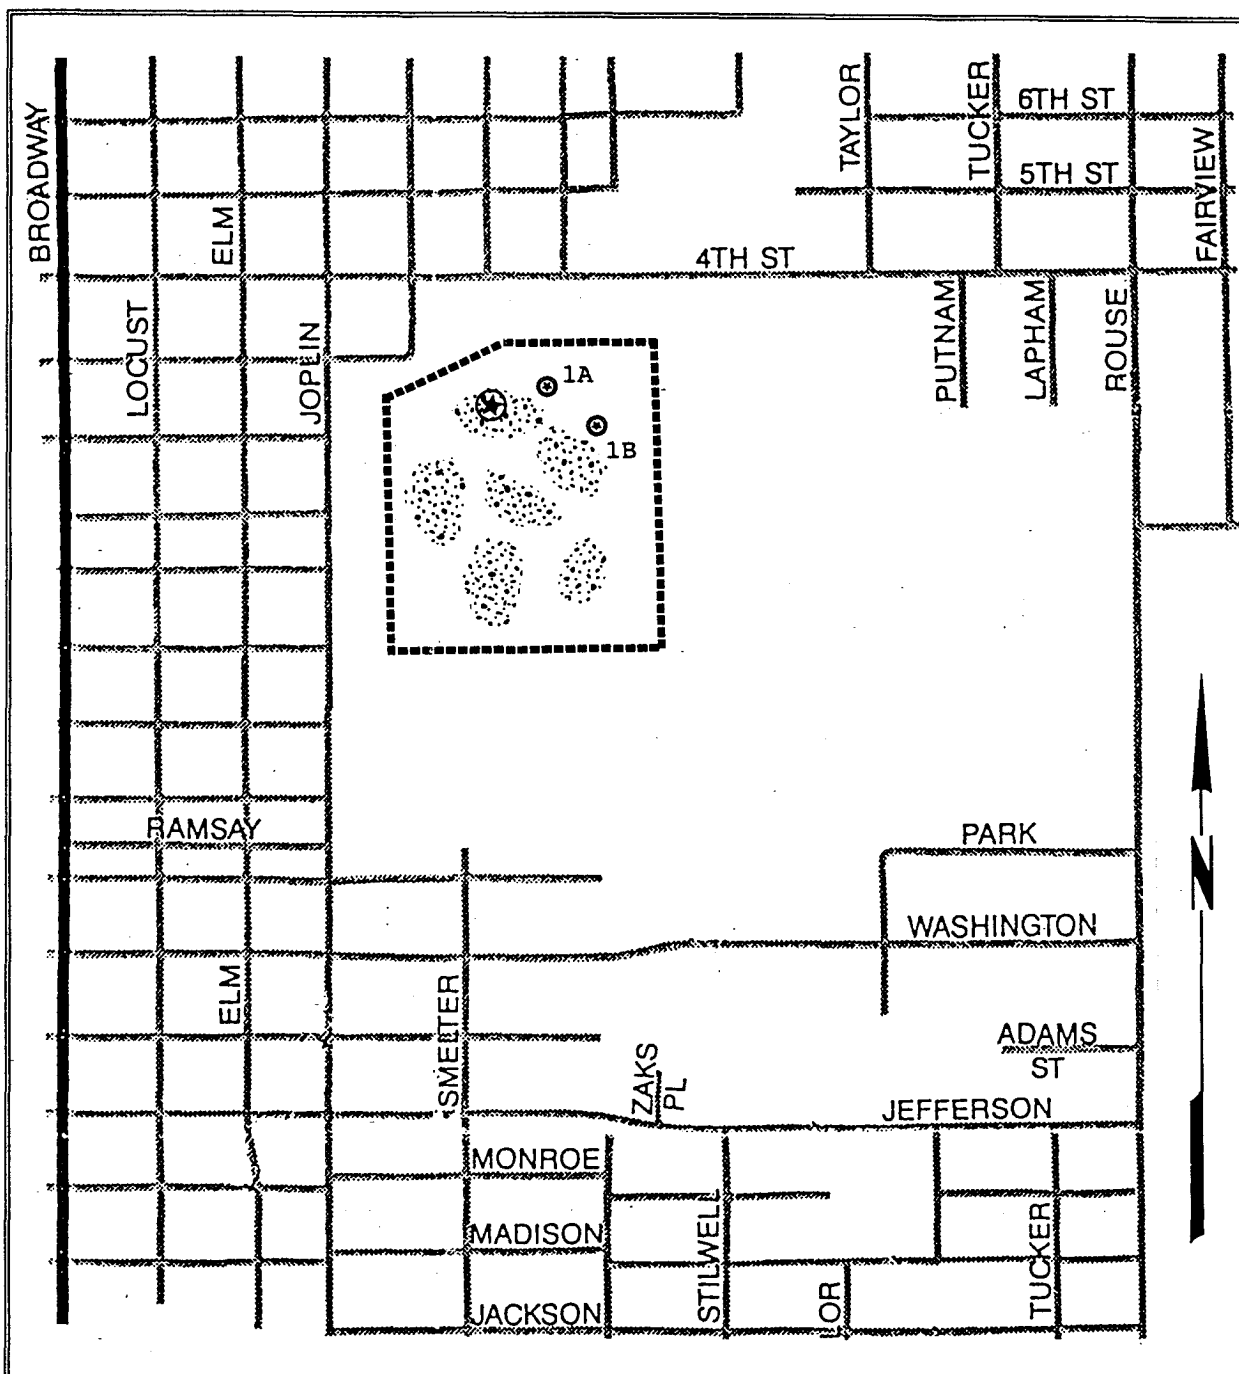
FIGURE 2
 SAMPLE LOCATION MAP

LEGEND: - - - Site boundary
 ••• Waste slag piles
 ⊕ Soil sample location
 ⊙ Water sample location

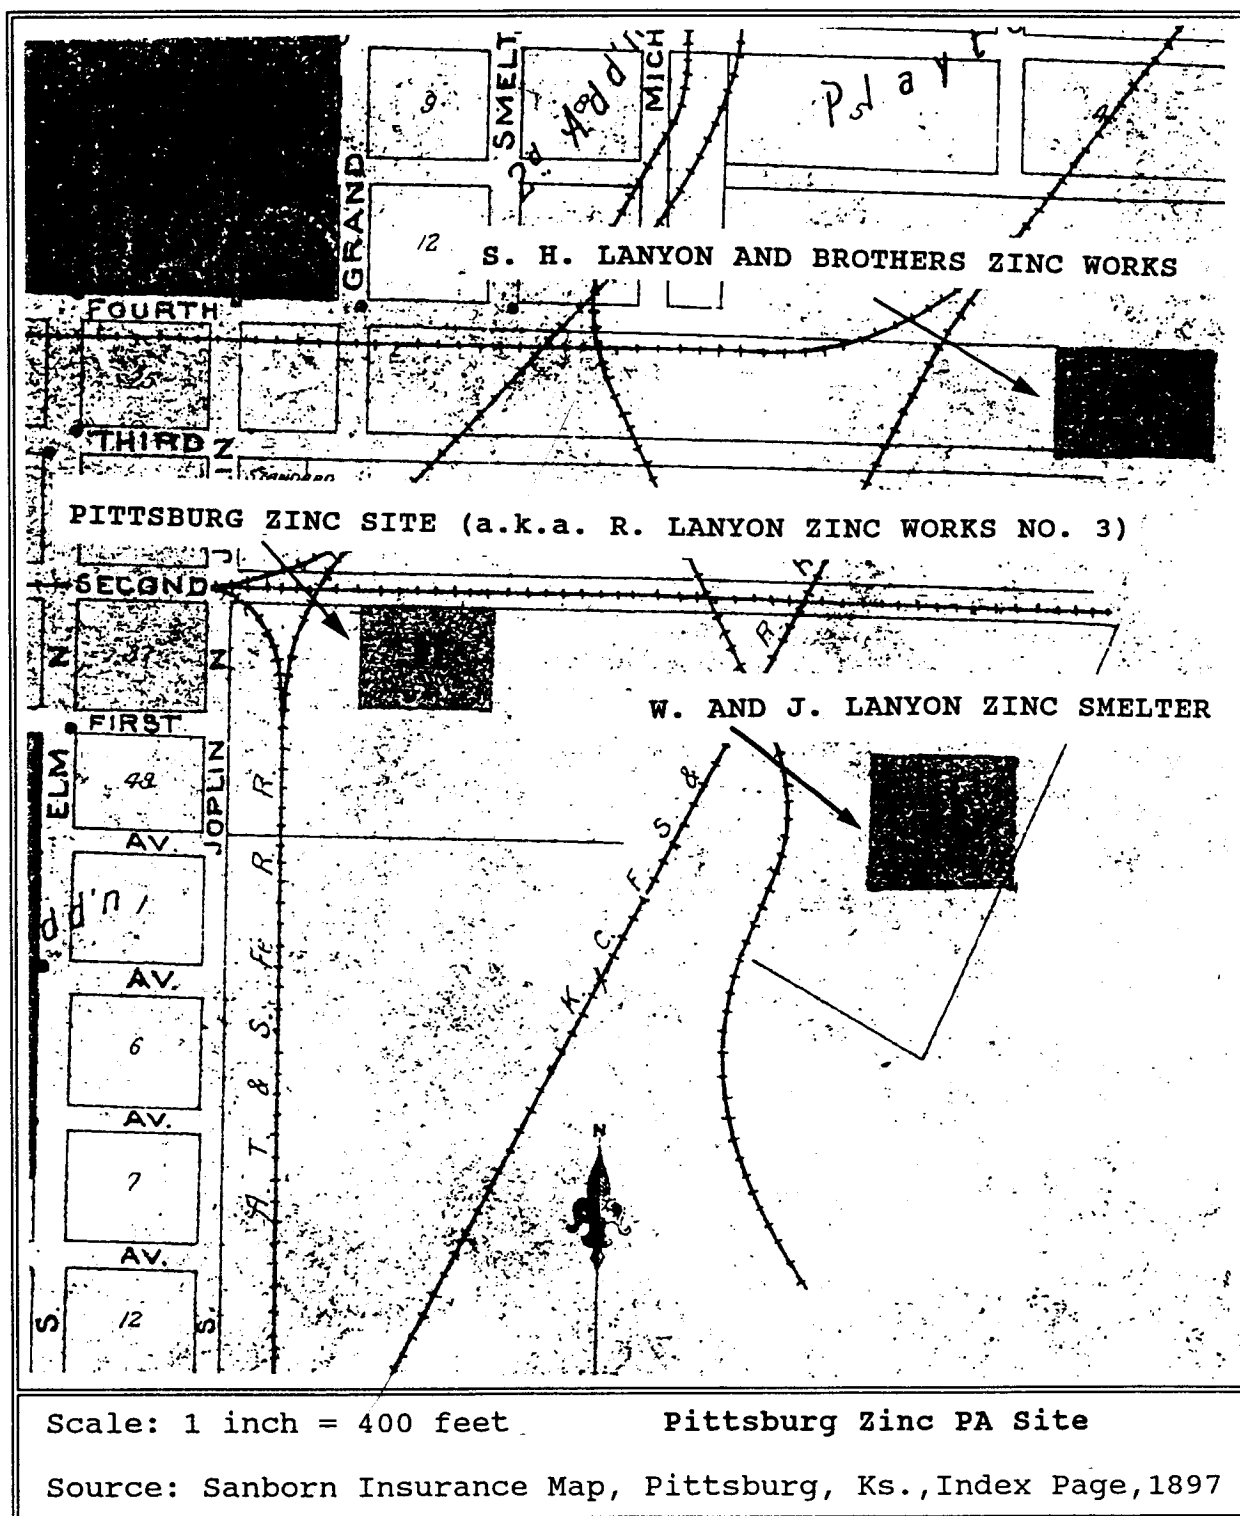
Figure 4: Smelter Locations Map - Pittsburgh Zinc Site

The site is located within a light industrial section of Pittsburg located southeast of the downtown area. Pittsburg State University is located 1/4 mile to the south. The area of the site includes the location of the smelter operation and the surrounding area where slag piles are presently located. The approximate size of the site is 1200 feet by 800 feet or about 22 acres. The smelter furnaces and processing was located at the north end of the site. A large water supply pond was located about 30 feet north of the smelter. Five furnaces were located on site (see Figure 3). Two additional smelters owned and operated by the Lanyon brothers were near the Pittsburg Zinc site property and may have contributed to the existing slag piles (Figure 4).

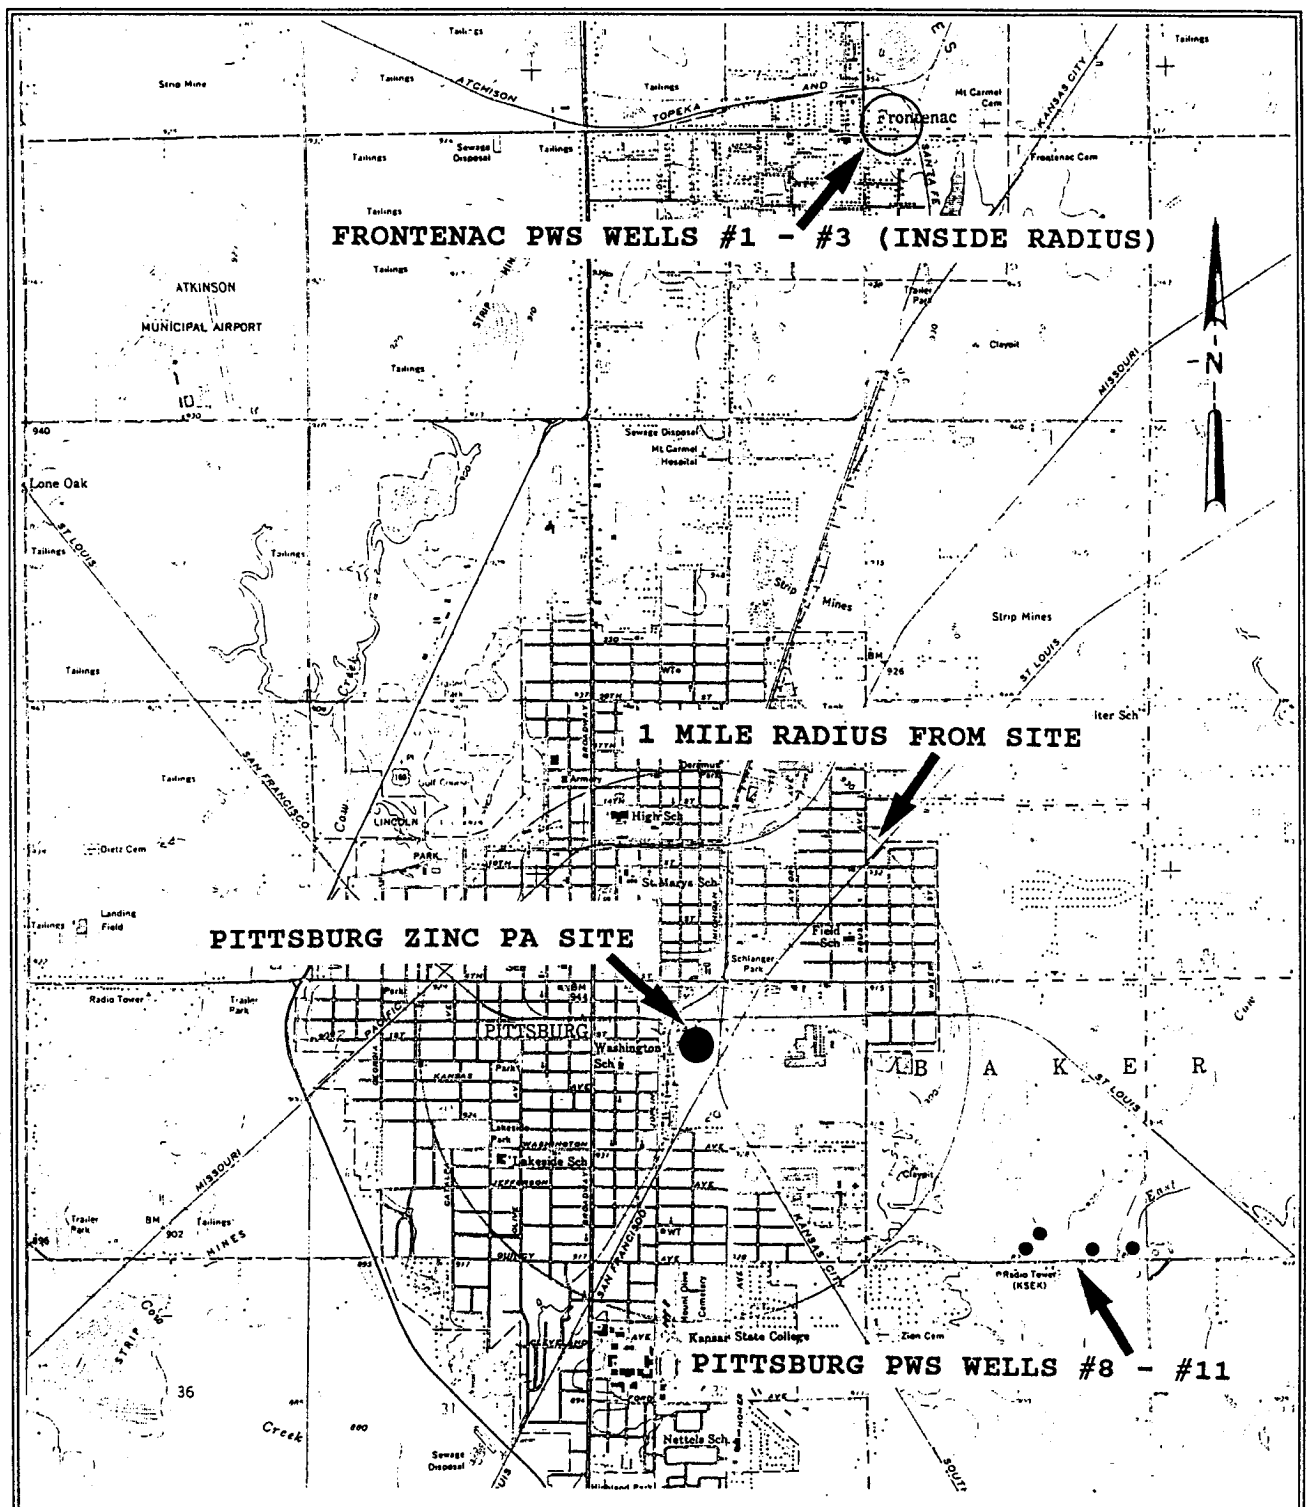
FIGURE 5: PITTSBURG AND FRONTENAC PWS WELLS LOCATION MAP

The ground water use within the City of Pittsburg for drinking water purposes is limited to the PWS wells which are located in the City of Pittsburg (see Figure 5). The wells are screened at depths exceeding 600 feet. The likelihood of possible contamination of the ground water resulting from leaching of the slag residual piles on site is remote. The aquifer is somewhat protected from surface contamination by its relative depth from the ground surface and the low potential for leaching of the residual smelter wastes.

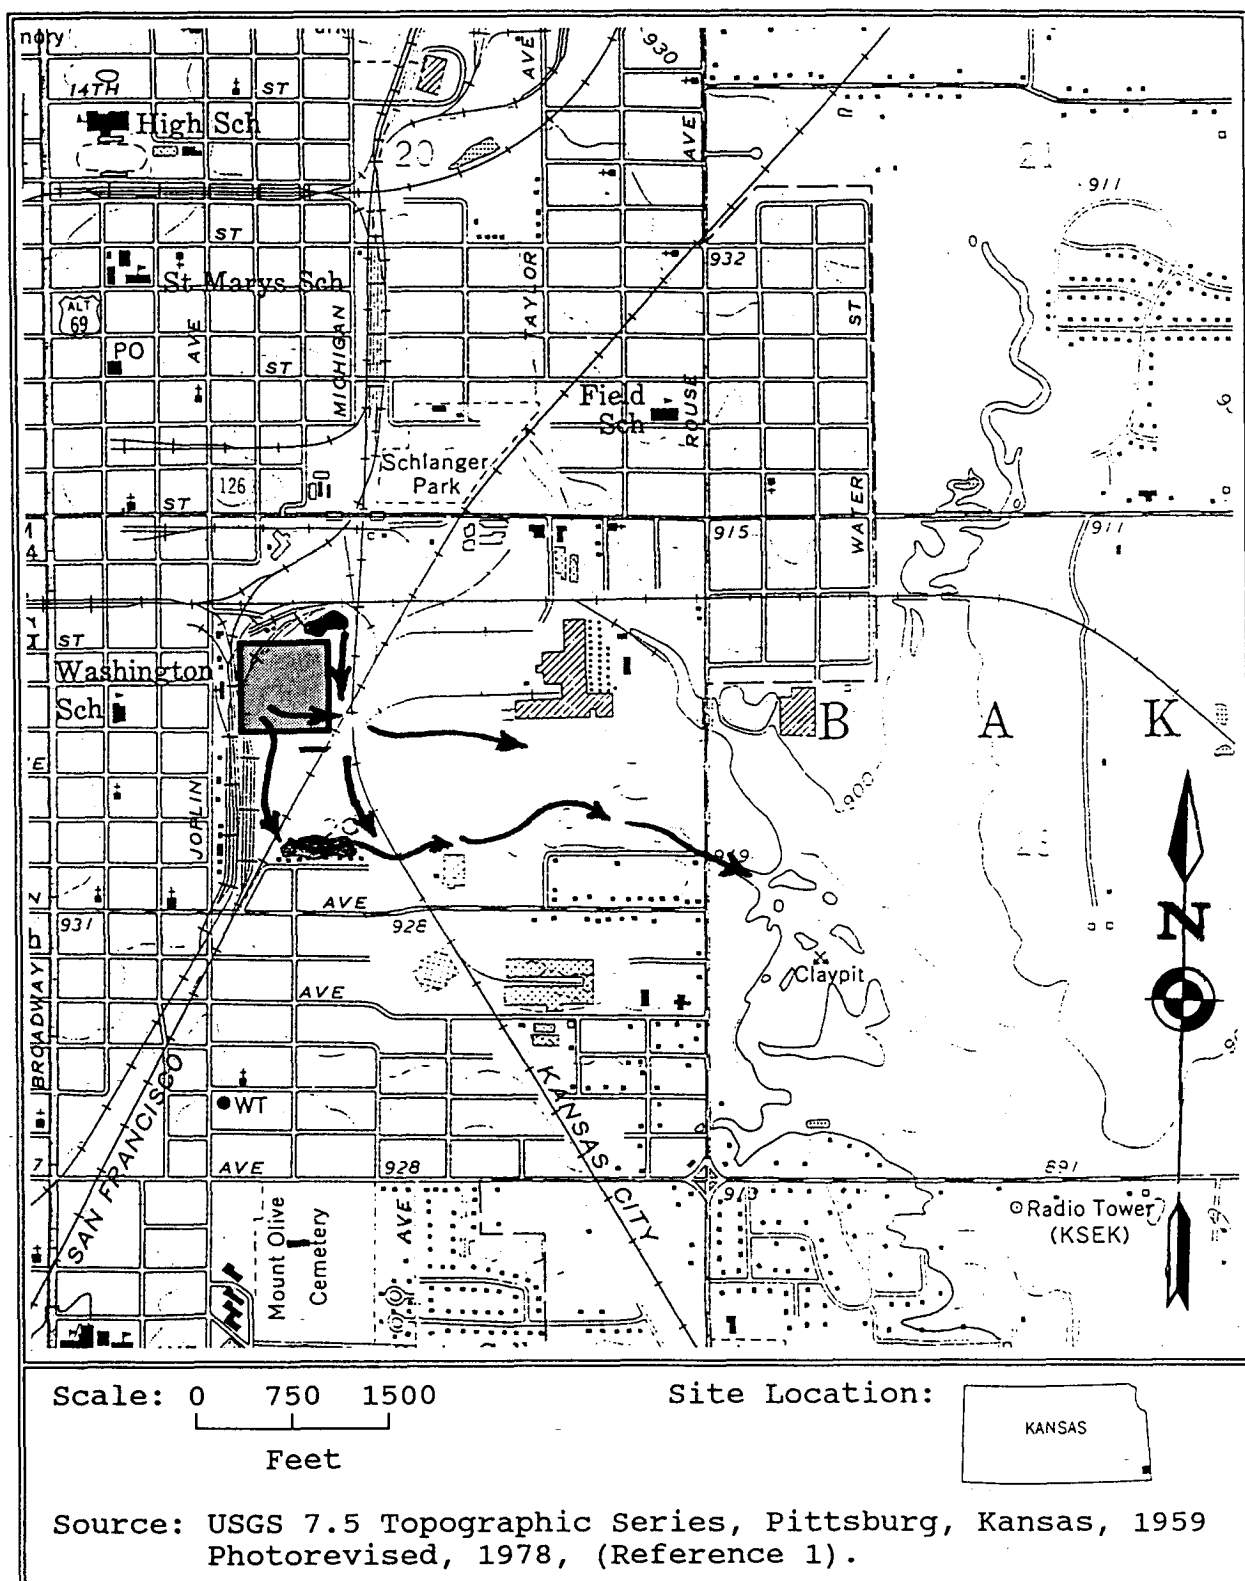
FIGURE 6: SURFACE WATER PATHWAY ROUTE - PITTSBURG ZINC PA SITE

The site is approximately 1/4 mile from an intermittent stream that flows into claypits (ponds) before reaching East Cow Creek, a perennial tributary stream of Cow Creek. The surface water pathway route leading to East Cow Creek is shown in Figure 6. Surface drainage flows southeasterly from the site or remains in depressed areas within the south and east sections of the site. The former pond area north of the smelter site appears to retain surface water periodically. The site is within the 100-500 year floodplain of the Cow Creek drainage basin (Reference 1).

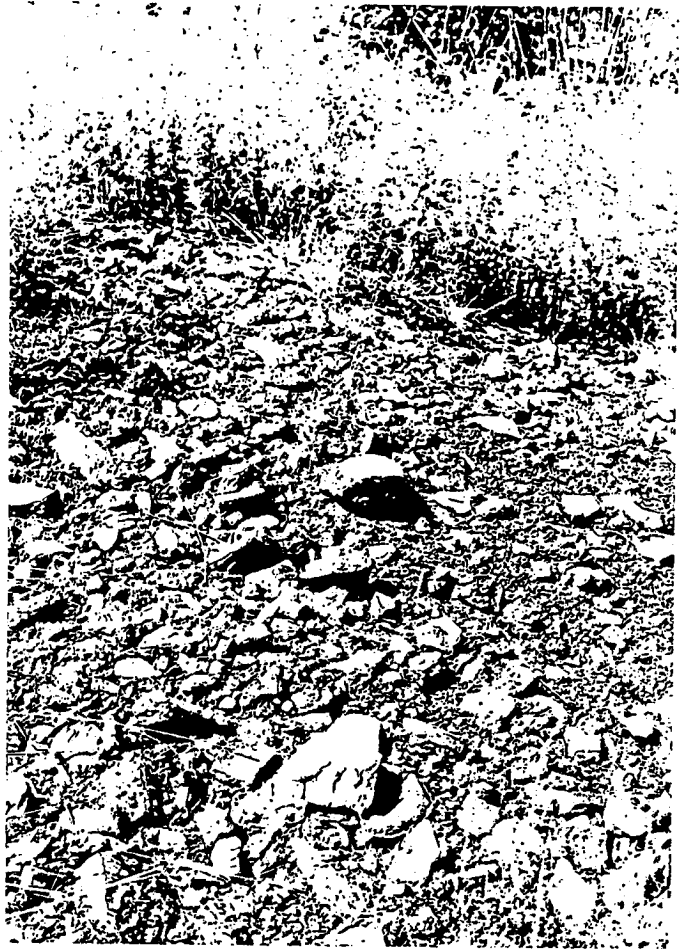
Photo 1

Date September 9, 1993
Time 2:15 p.m.
Location Pittsburg Zinc Site
Direction viewing west
Photographer J. Alldritt
Comments
 Pile of smelter debris
 showing broken retort,
 bricks, and typical
 slag materials.

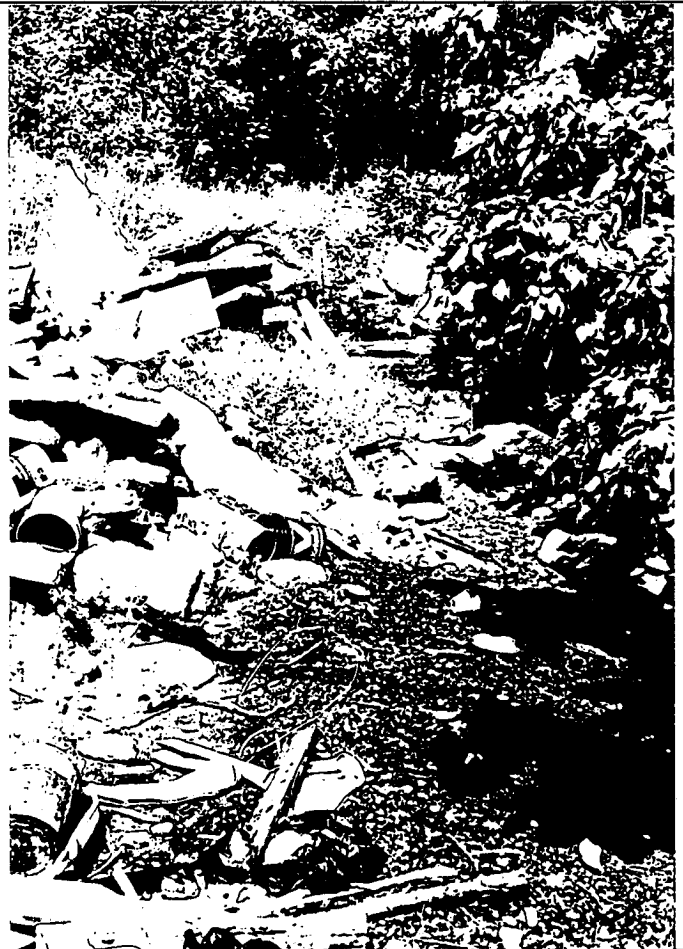
Photo 2

Date September 9, 1993
Time 1:45 p.m.
Location Pittsburg Zinc Site
Direction viewing northeast
Photographer J. Alldritt
Comments
 Solid waste, primarily
 construction debris
 (note concrete), buckets,
 and typical household
 trash. Limited amount
 of trash being dumped
 in the northeast
 area of the site.

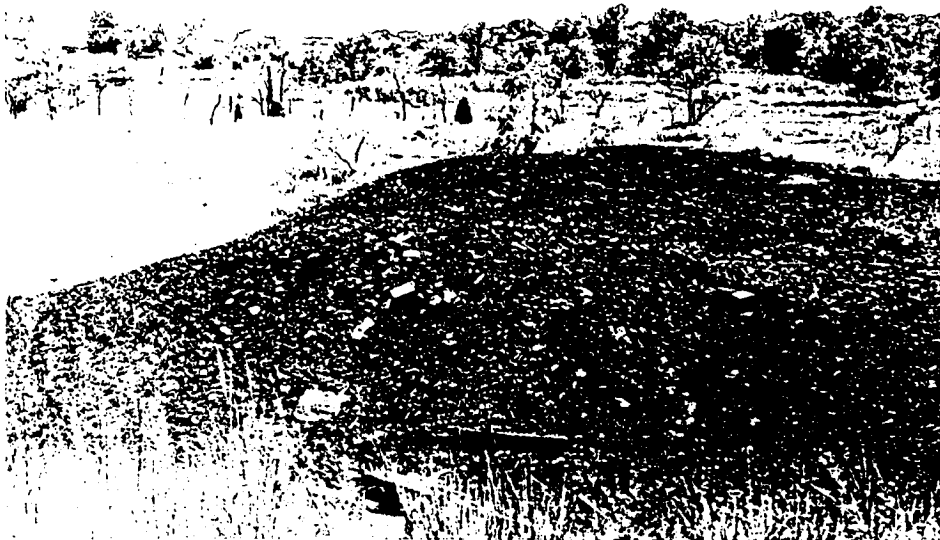
Photo 3

pond area for zinc

works.

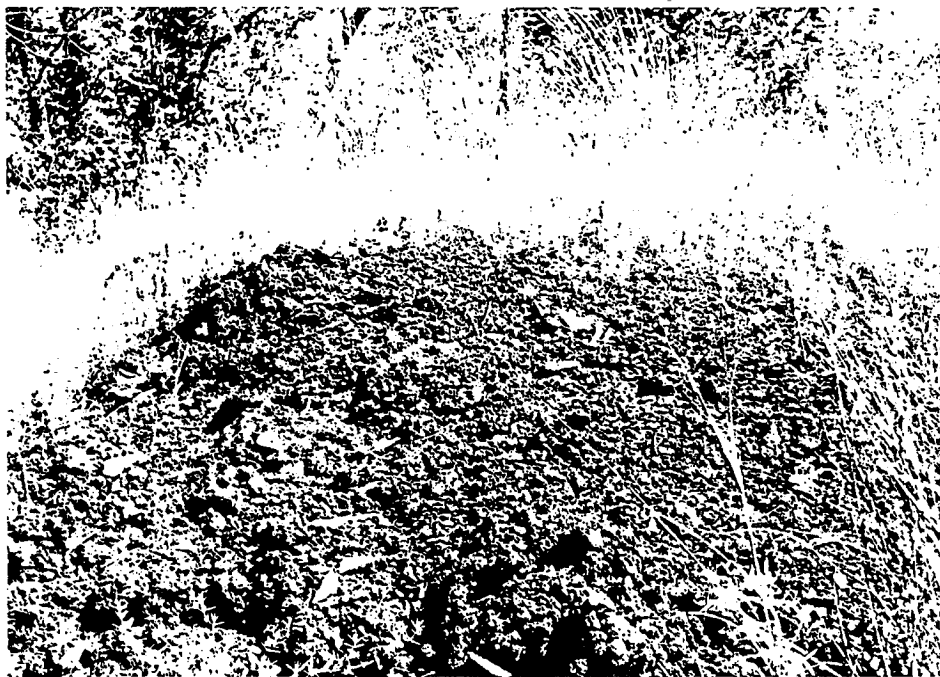
Photo 4

acterized by hard melted

ore appearance.

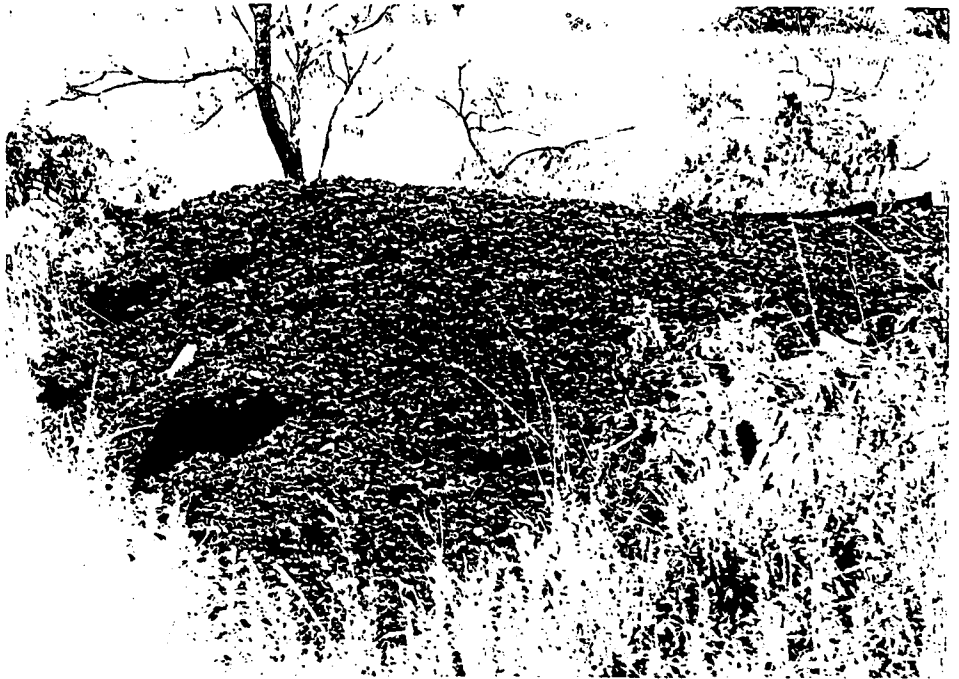
Photo 5

Date September 9, 1993
Time 2:20 p.m.
Location Pittsburg Zinc Site
Direction viewing east
Photographer J. Alldritt
Comments Typical slag pile on
site. Lush grasses
growing in the vicinity
shows how supportive
and fertile local
soils can be.

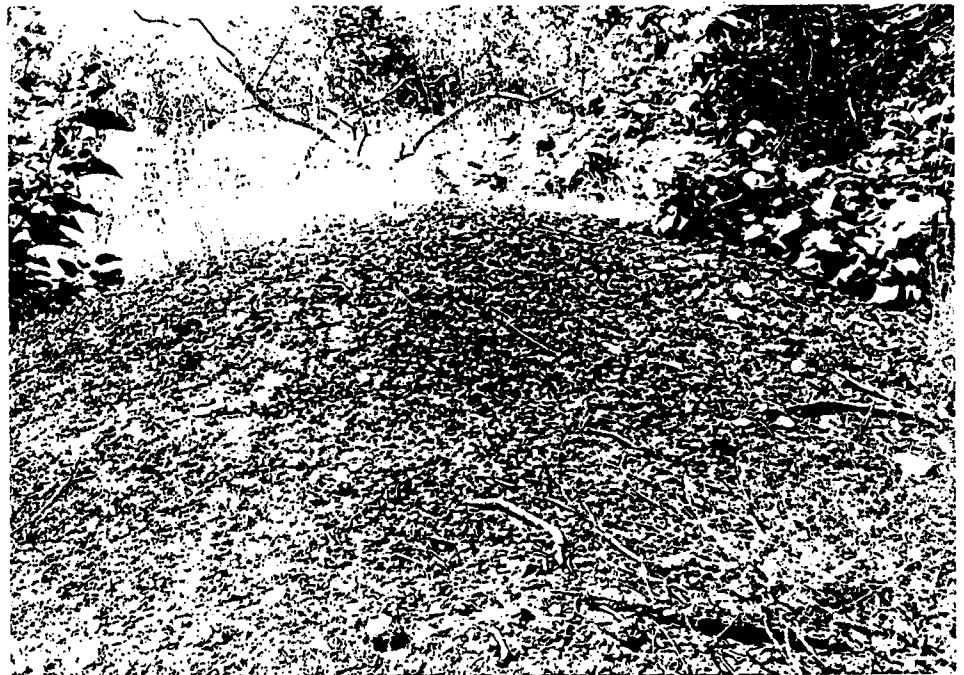
Photo 6

Date September 9, 1993
Time 2:30 p.m.
Location Pittsburg Zinc Site
Direction viewing south
Photographer J. Alldritt
Comments Slag waste pile showing
the inability of
vegetative support.
Piles of slag range from
fine granular particles
to large consolidated
slag (see photo #4).
